Railings

1. Works under the 2018 BHIS were carried out to a 53 metre length of the railings from St Nicholas main gates to Lynch's Window.
2. Many options had been explored in 2017 for the repair of the gates and railings. Some metalworkers required complete removal of the railings to be cleaned down, grit-blasted and painted in their workshops. Repair and painting in-situ was our preference as the most appropriate, conservation-led approach.

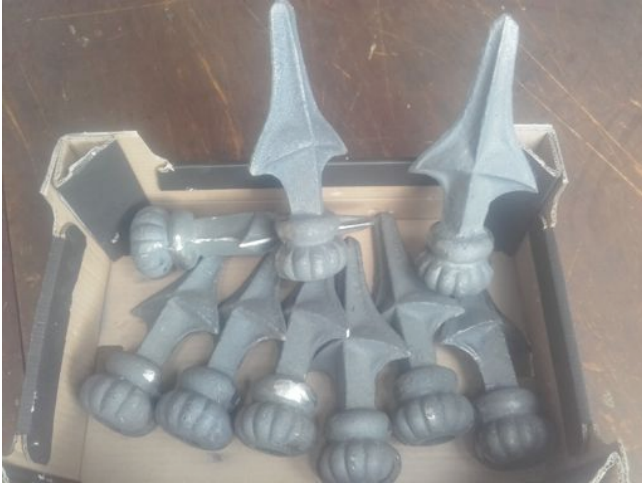
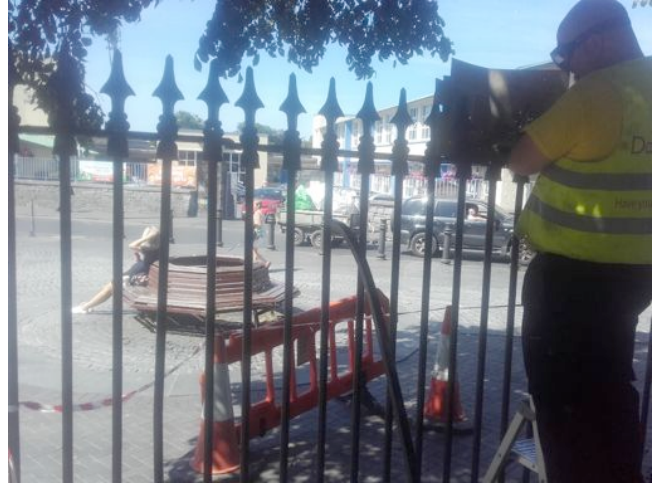
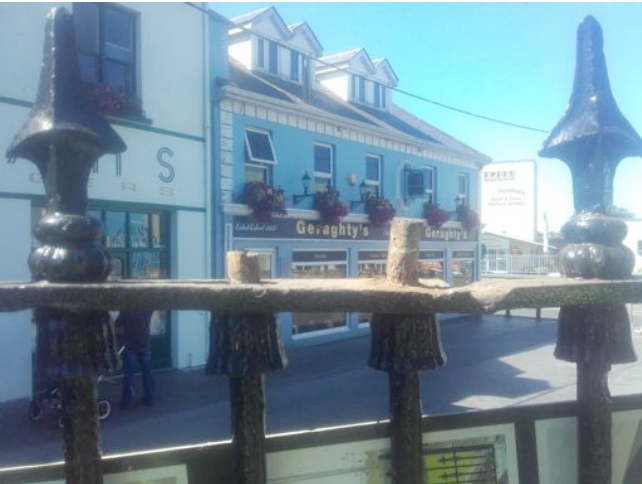
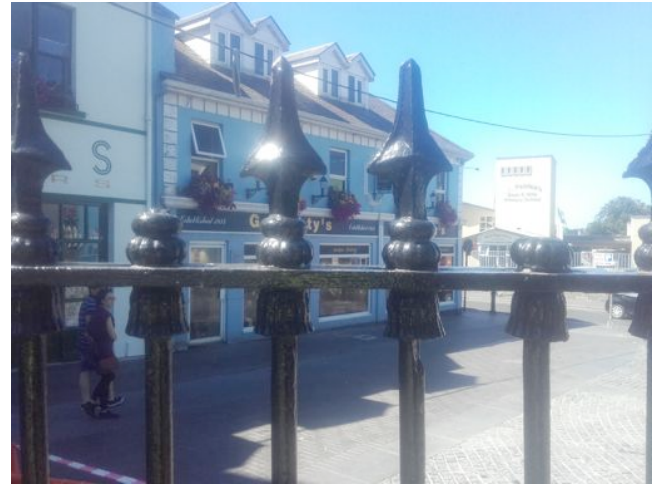
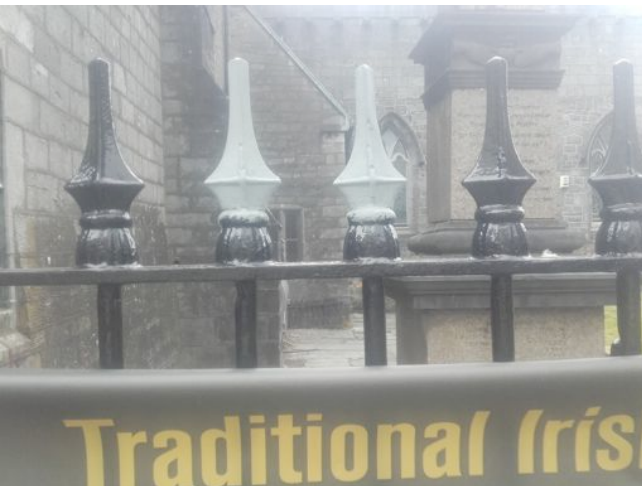
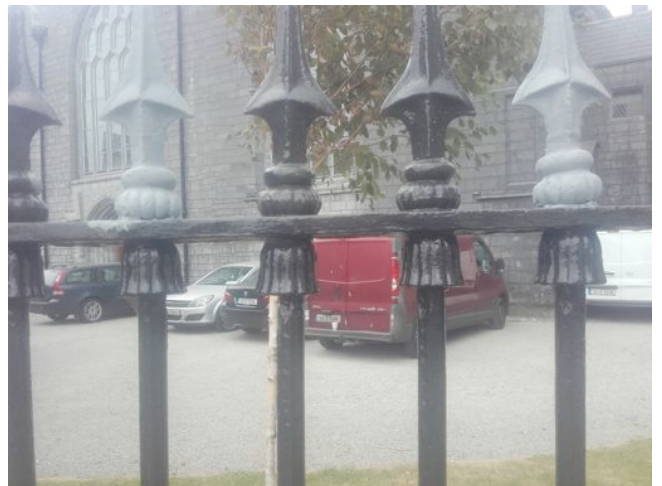
New finials cast and fitted prior to painting to both lengths of railings between south tower and Lynch's Window

3. Repairs were made by a craft blacksmith who had 23 no. missing or damaged finials or rail-heads cast using an original to make the mould and fitted them before painting. The finials were fitted to both lengths of railings - south tower to main gates and main gates to Lynch's Window

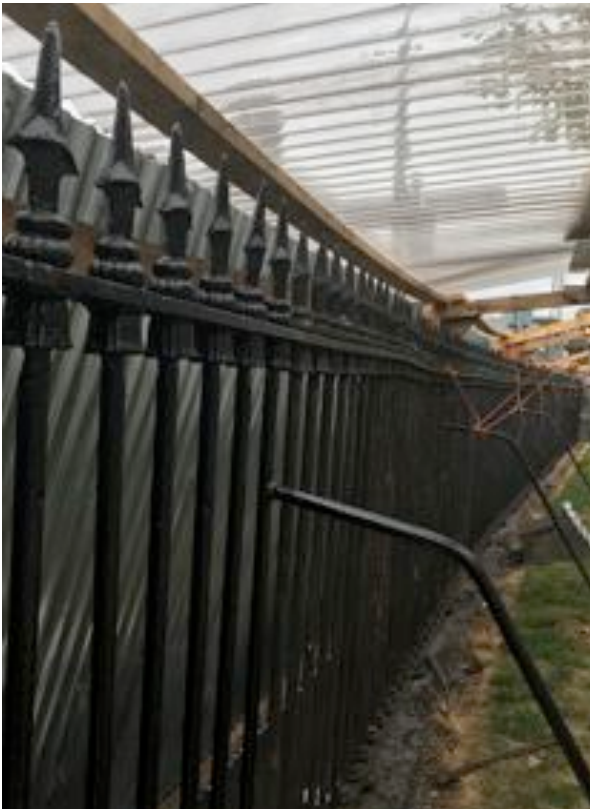
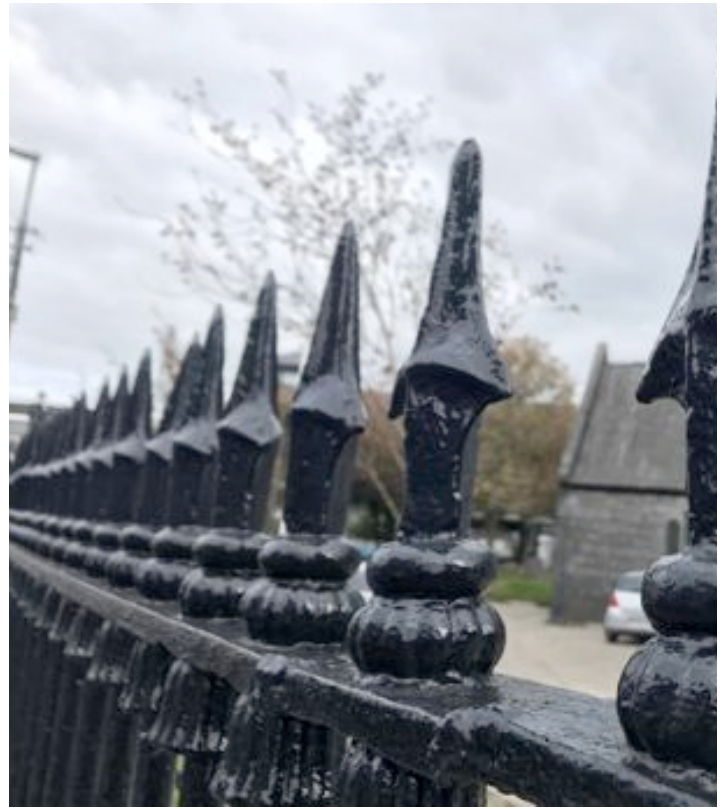
Temporary structure to protect from weather and for public safety, designed to move along as works progress

4. The railings were cleaned down of rust and corrosion using a mechanical process and painted using a high-quality metal paint specification. In order to allow cleaning and painting to progress under the best environmental conditions, a temporary superstructure of timber and metal sheeting was put in place to allow all-weather working. This superstructure was moved along as works progressed.

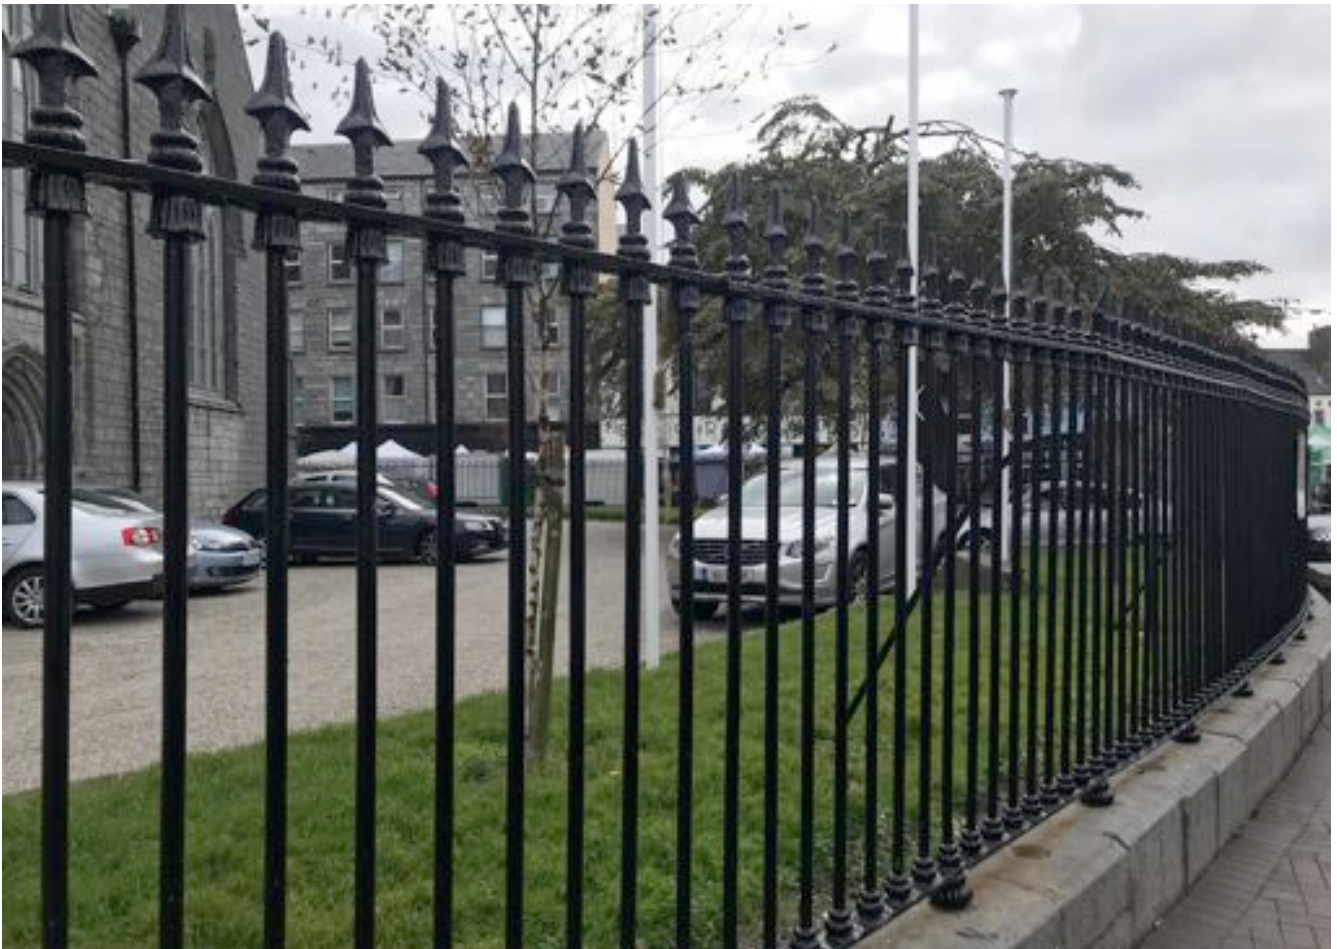
Conservation and painting to 53 metre length between main gates and Lynch's Window

5. This work has now been satisfactorily completed.
